## TELEVISION TECHNICAL BULLETIN

**MODELS**    37AM12H                      37AM23H                      37AT25H

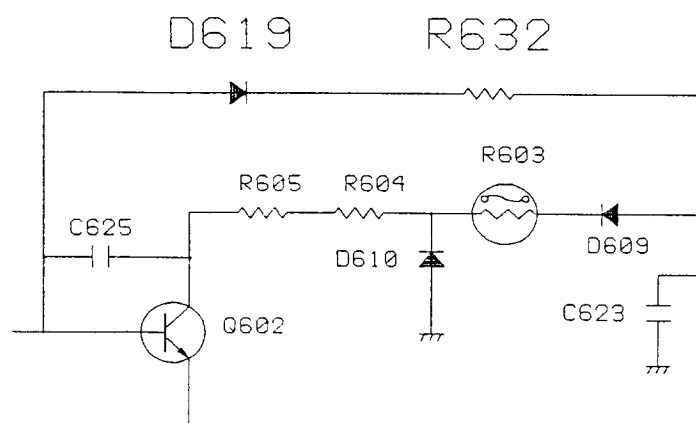
**SYMPTOM**    Q601 fails occasionally.

**CAUSE**        Noise spikes on the drive signal to Q601.

**ACTION**        Fit D619 and R632 as shown in the diagram below, on the print side of the main PWB, ensuring that no component shorts out.

Also change C713 to 1000uF, 16V.
